# **SOUND INSULATION TESTING IN DWELLINGS**

**Chris Dilworth, AWN Consulting**

# This Presentation

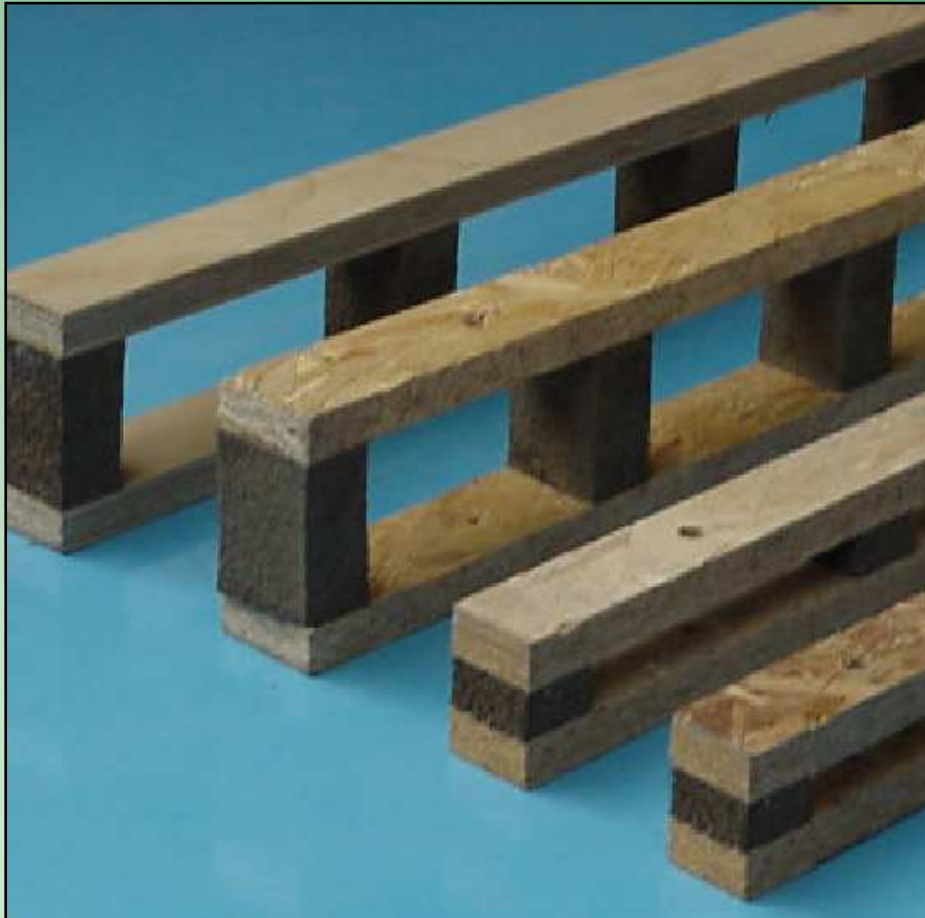
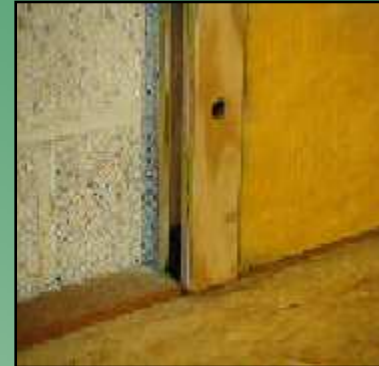
Proprietary isolating battens

- Suitable wall linings to be applied to one side of the wall must offer both **mass** and **isolation**.
- **Mass** is provided by using two layers of 15mm plasterboard.
- **Isolation** is provided by installing the plasterboard on an independent stud system or proprietary isolating “battens”.
