Pyrites the Building Control Experience

IBCI Conference 2008

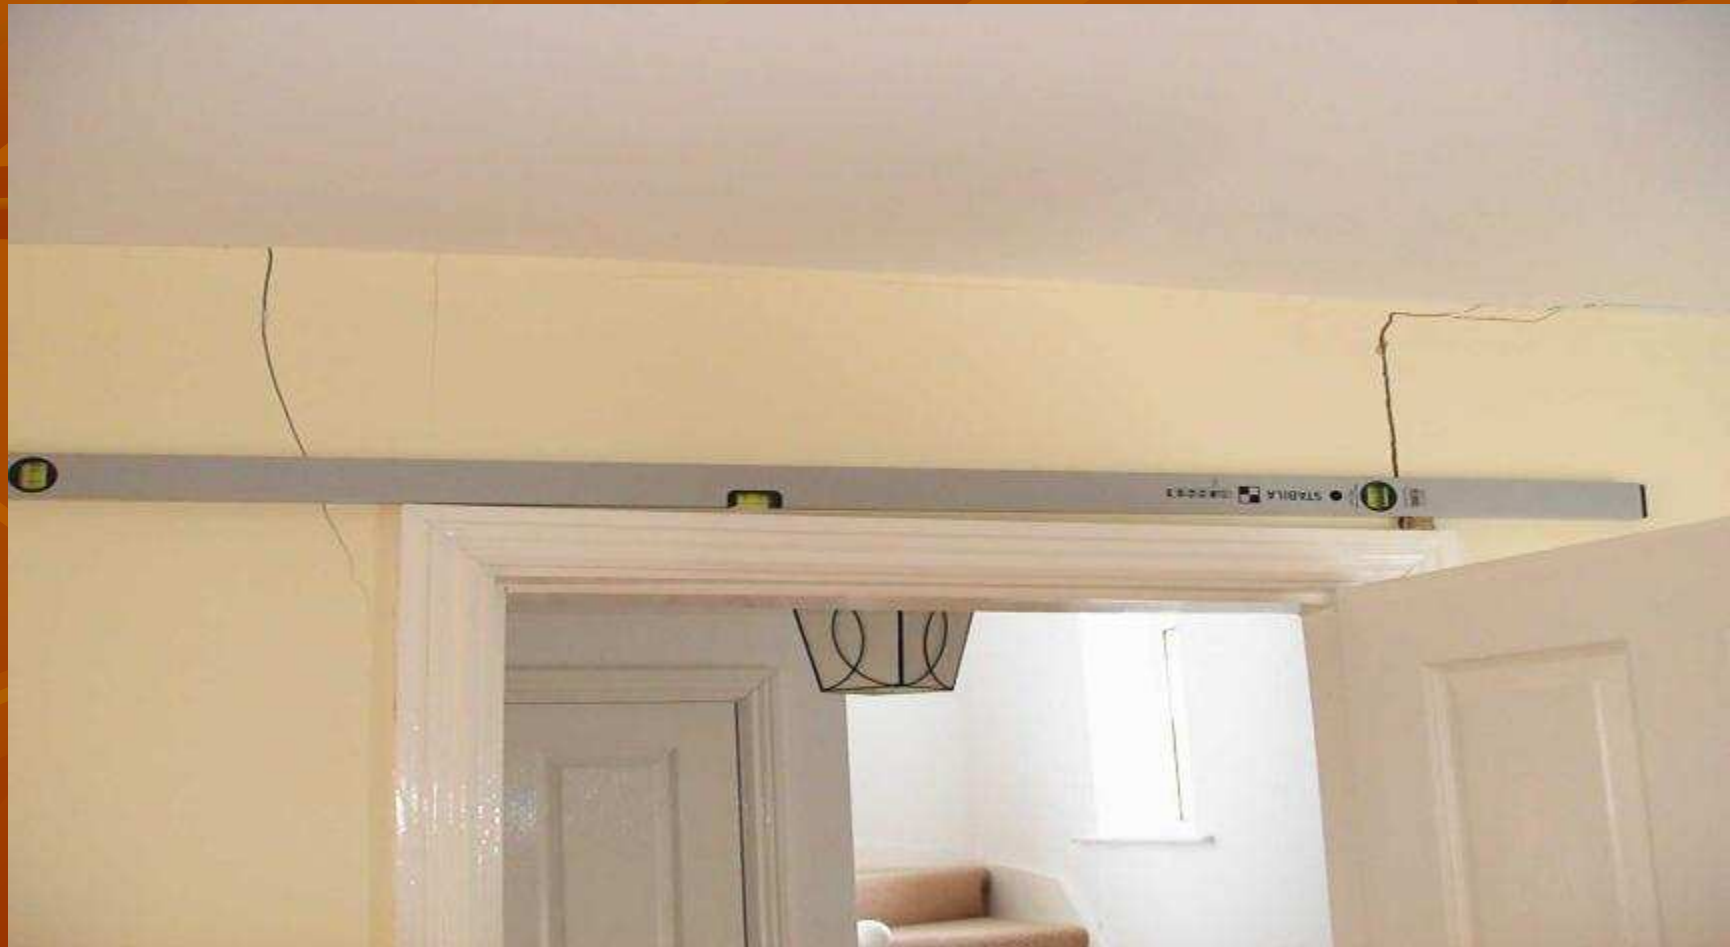
Structural Cracks on internal walls

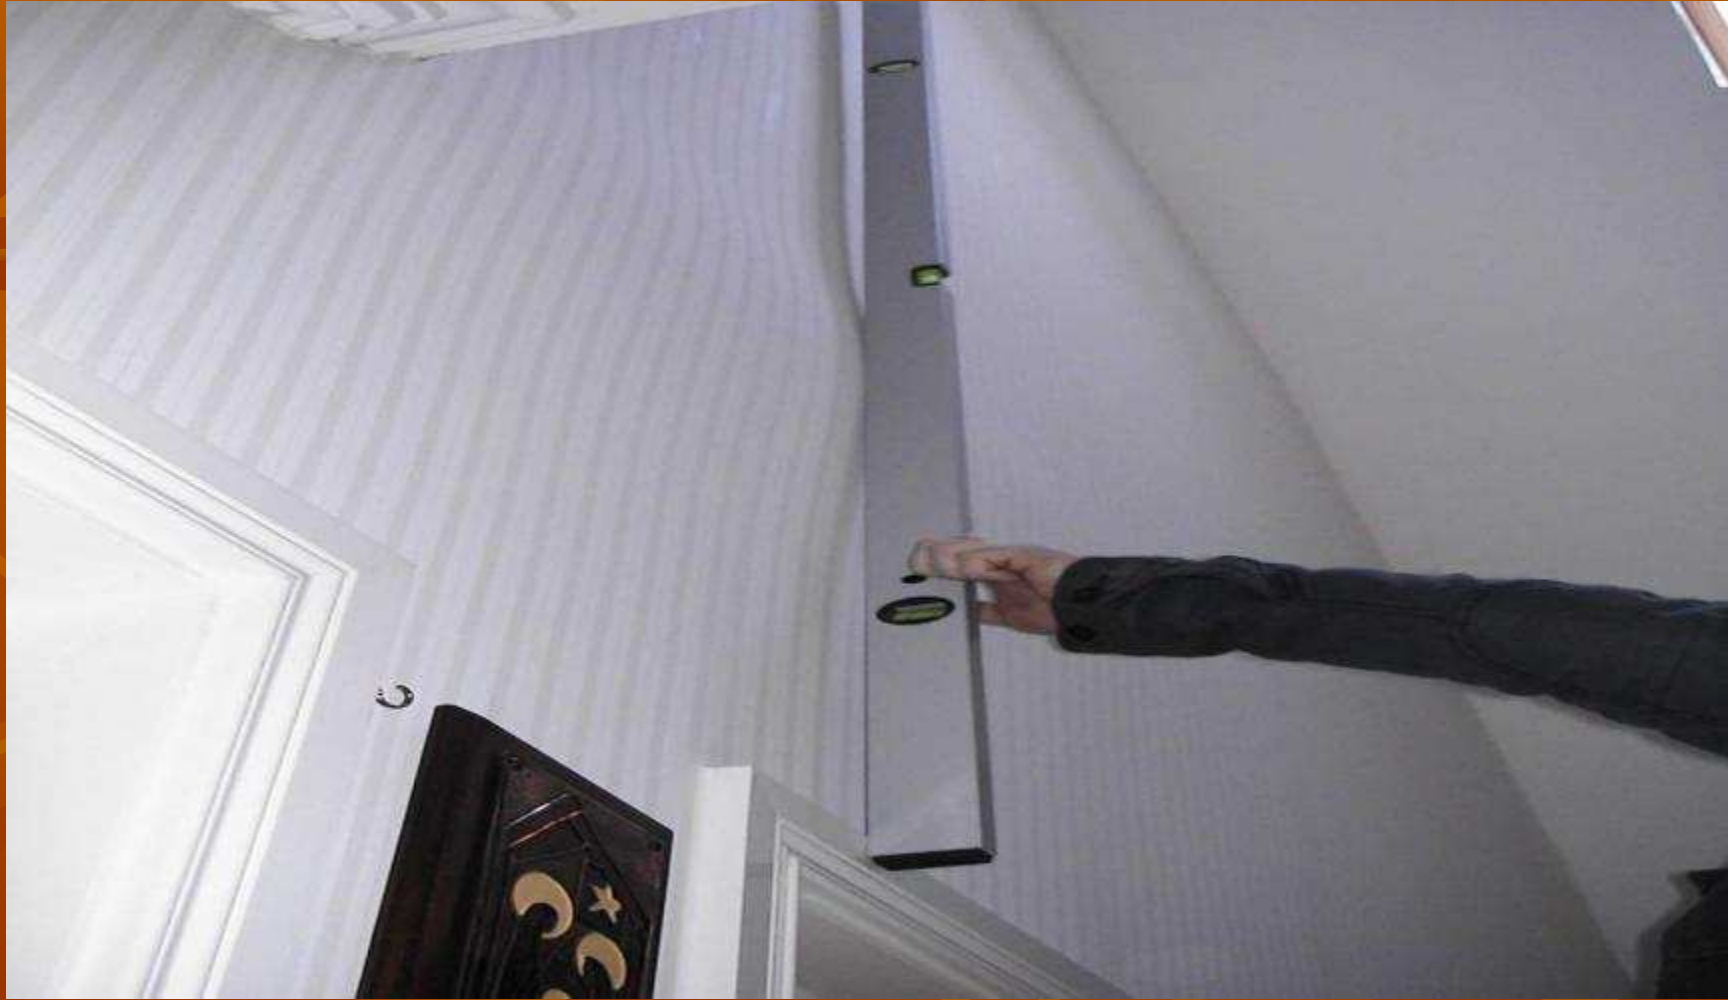
Bulging Internal Wall

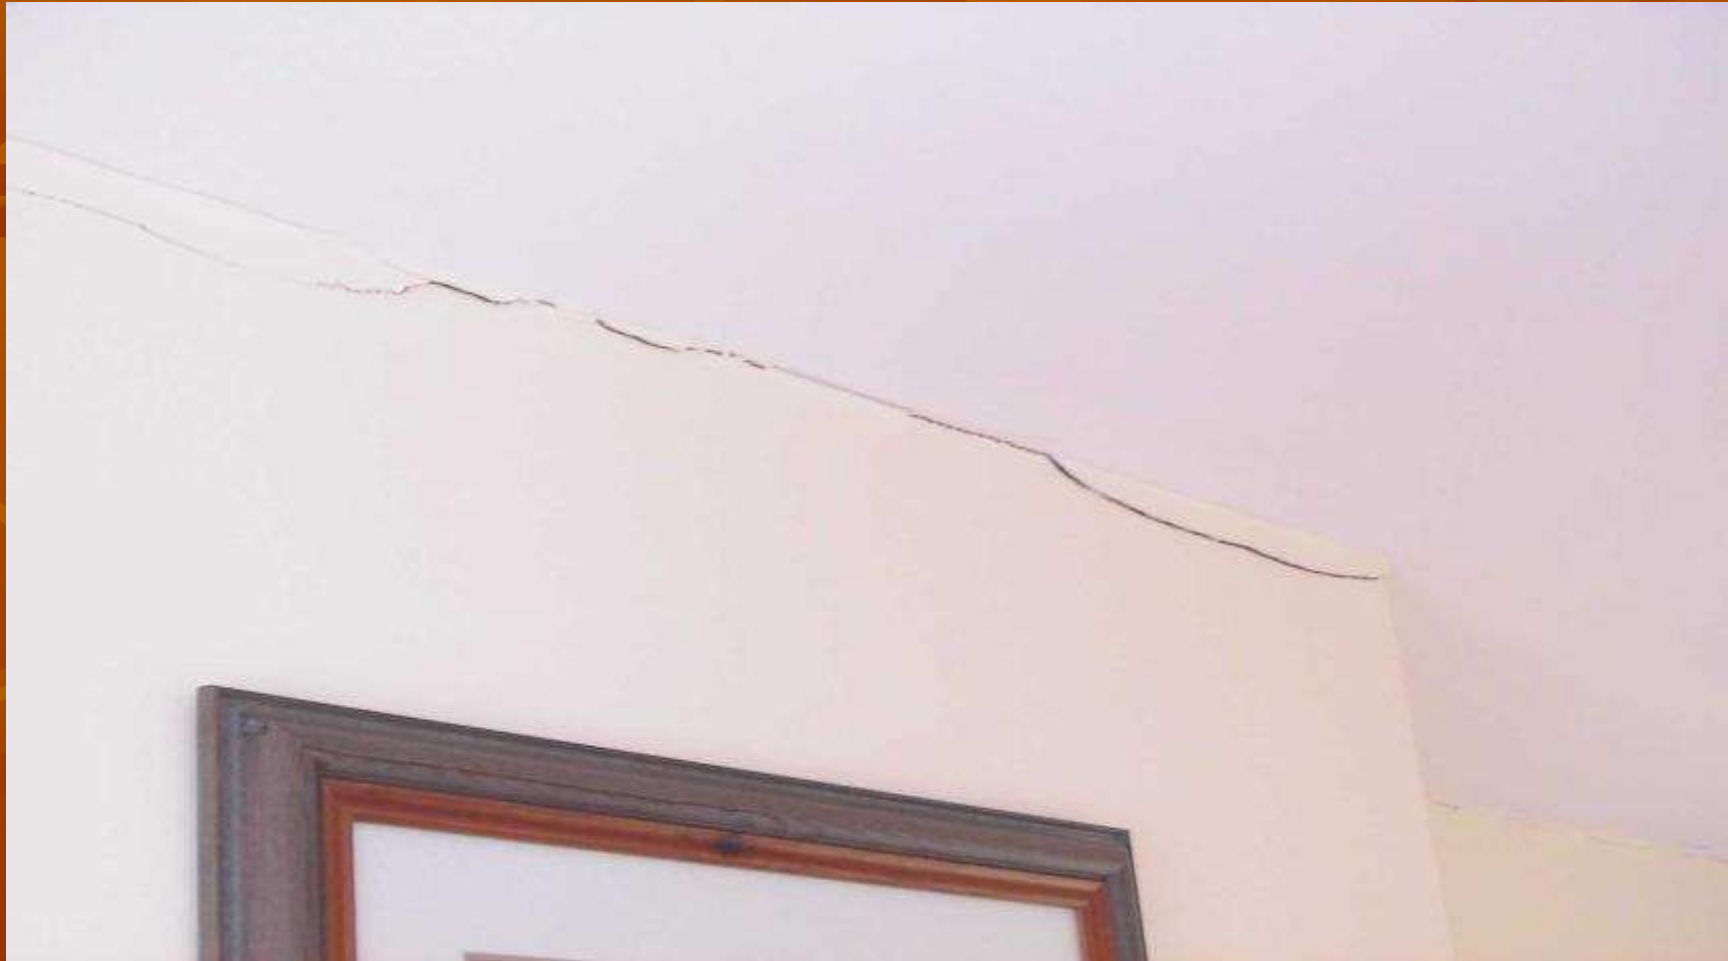
Horizontal cracking at ceiling level

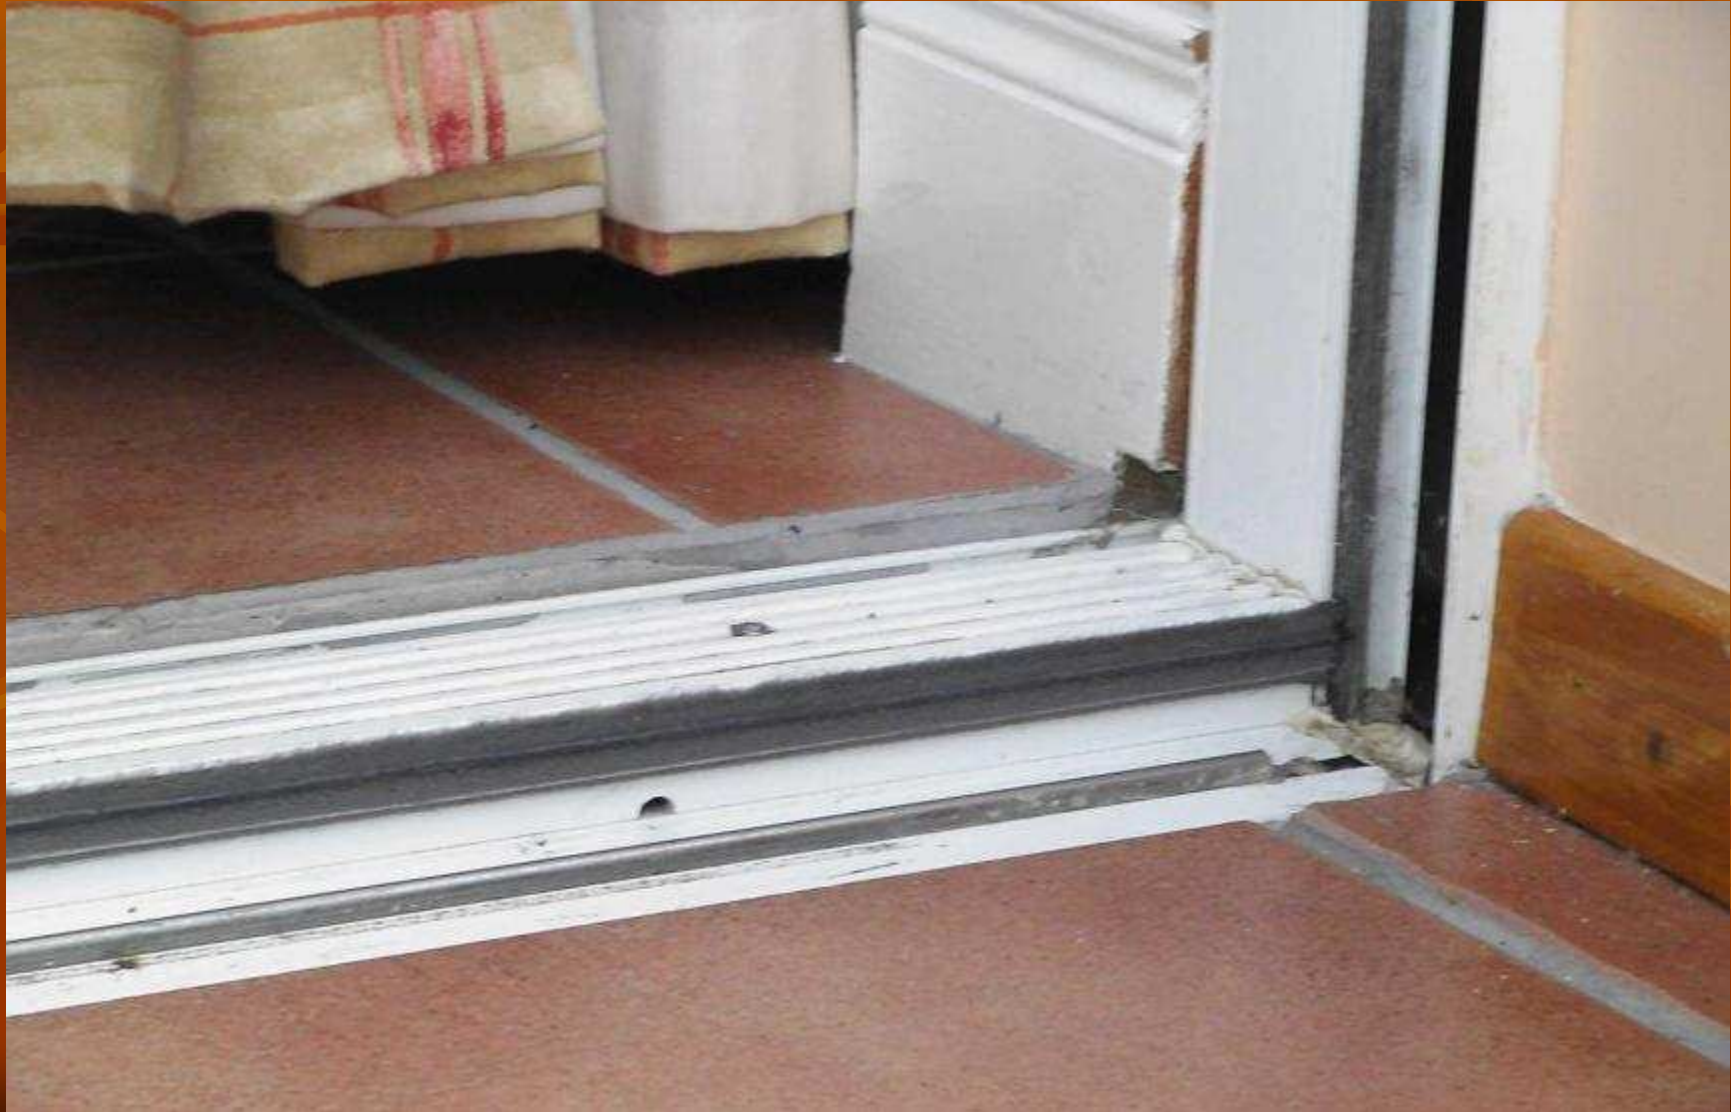
Pyrites Causing floor to rise

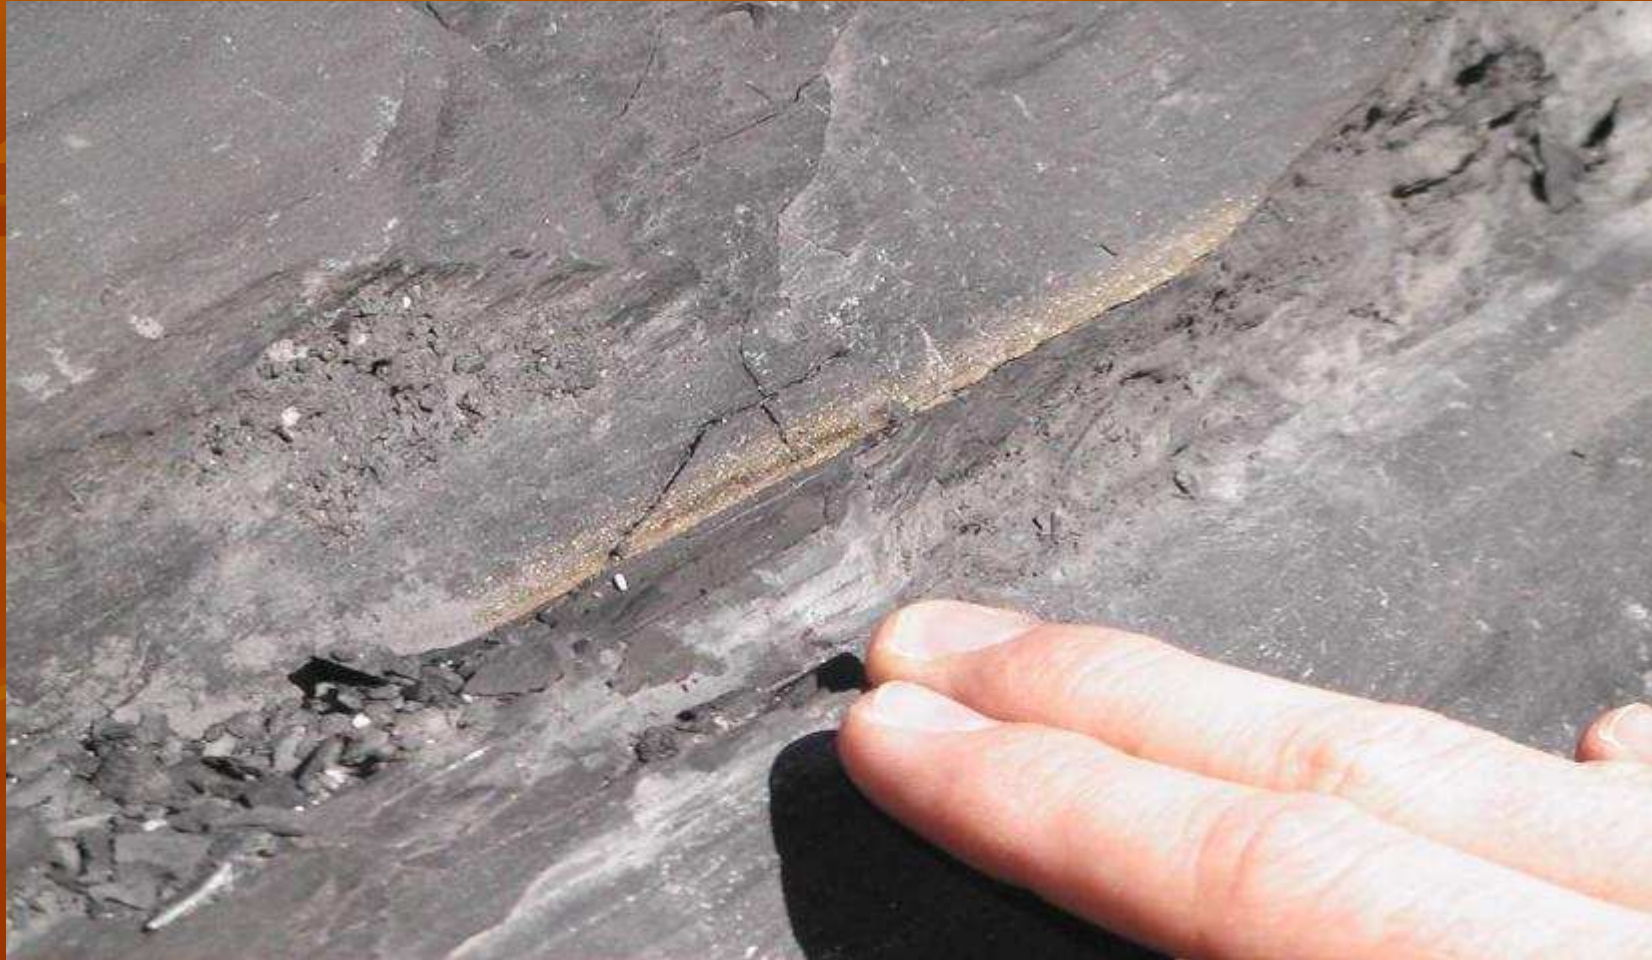
Pyrites in Rock

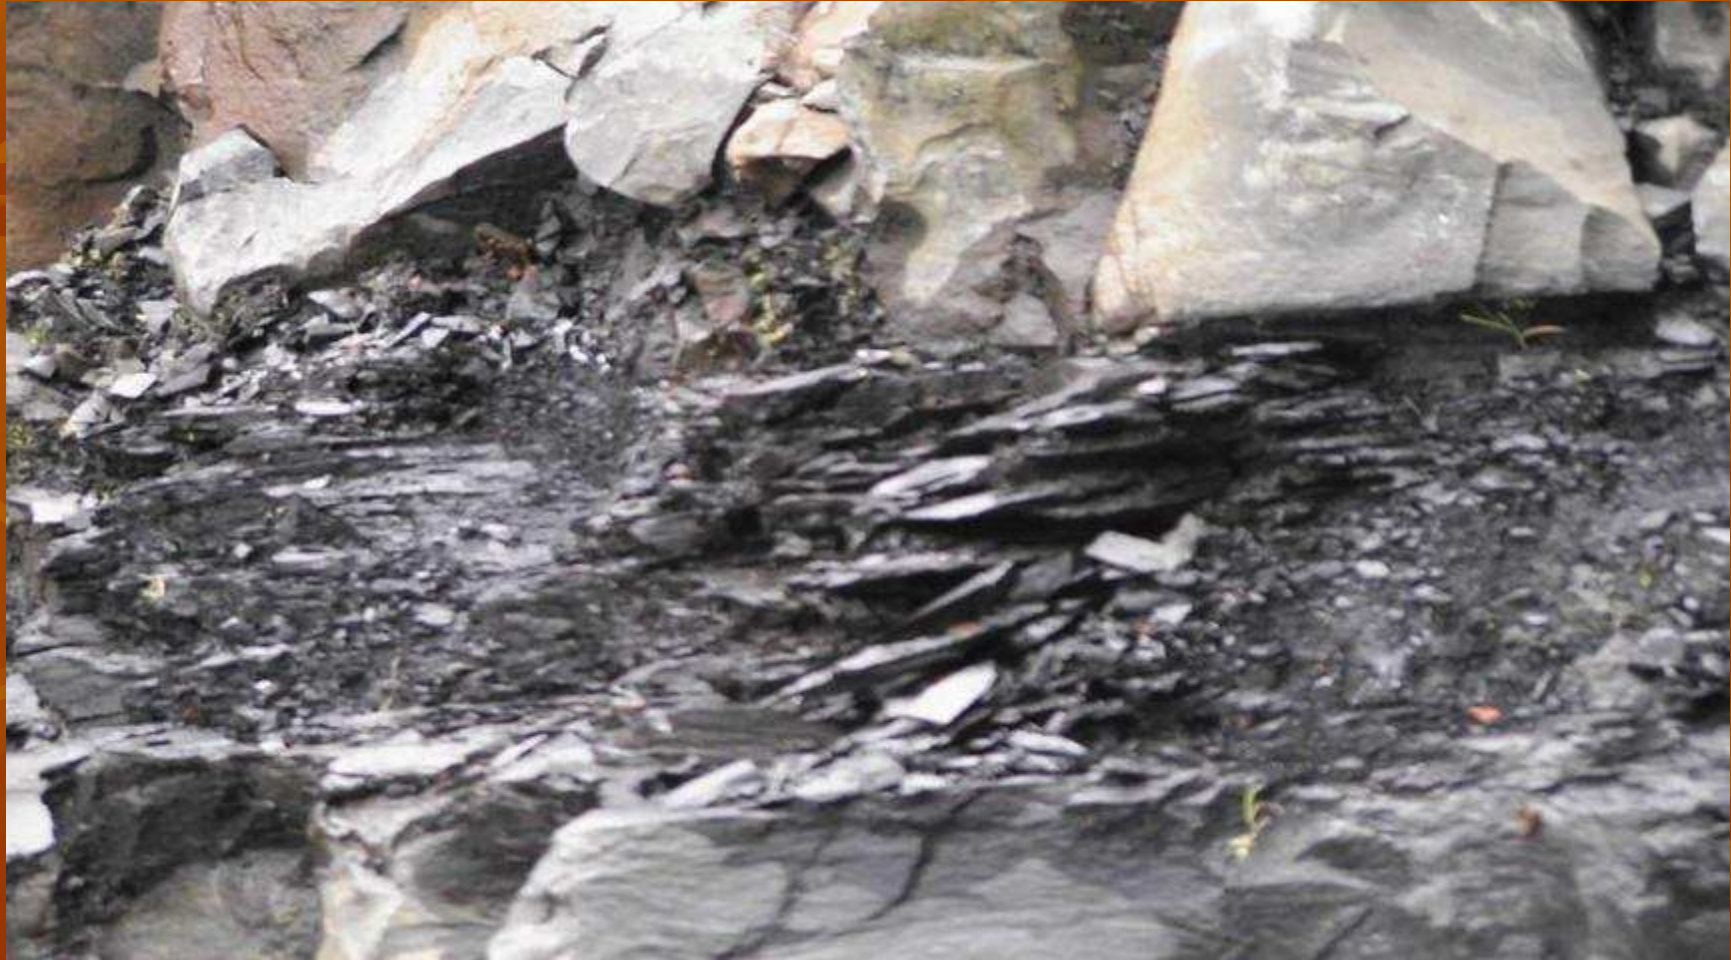
Pyrites in Shale Slate Rock

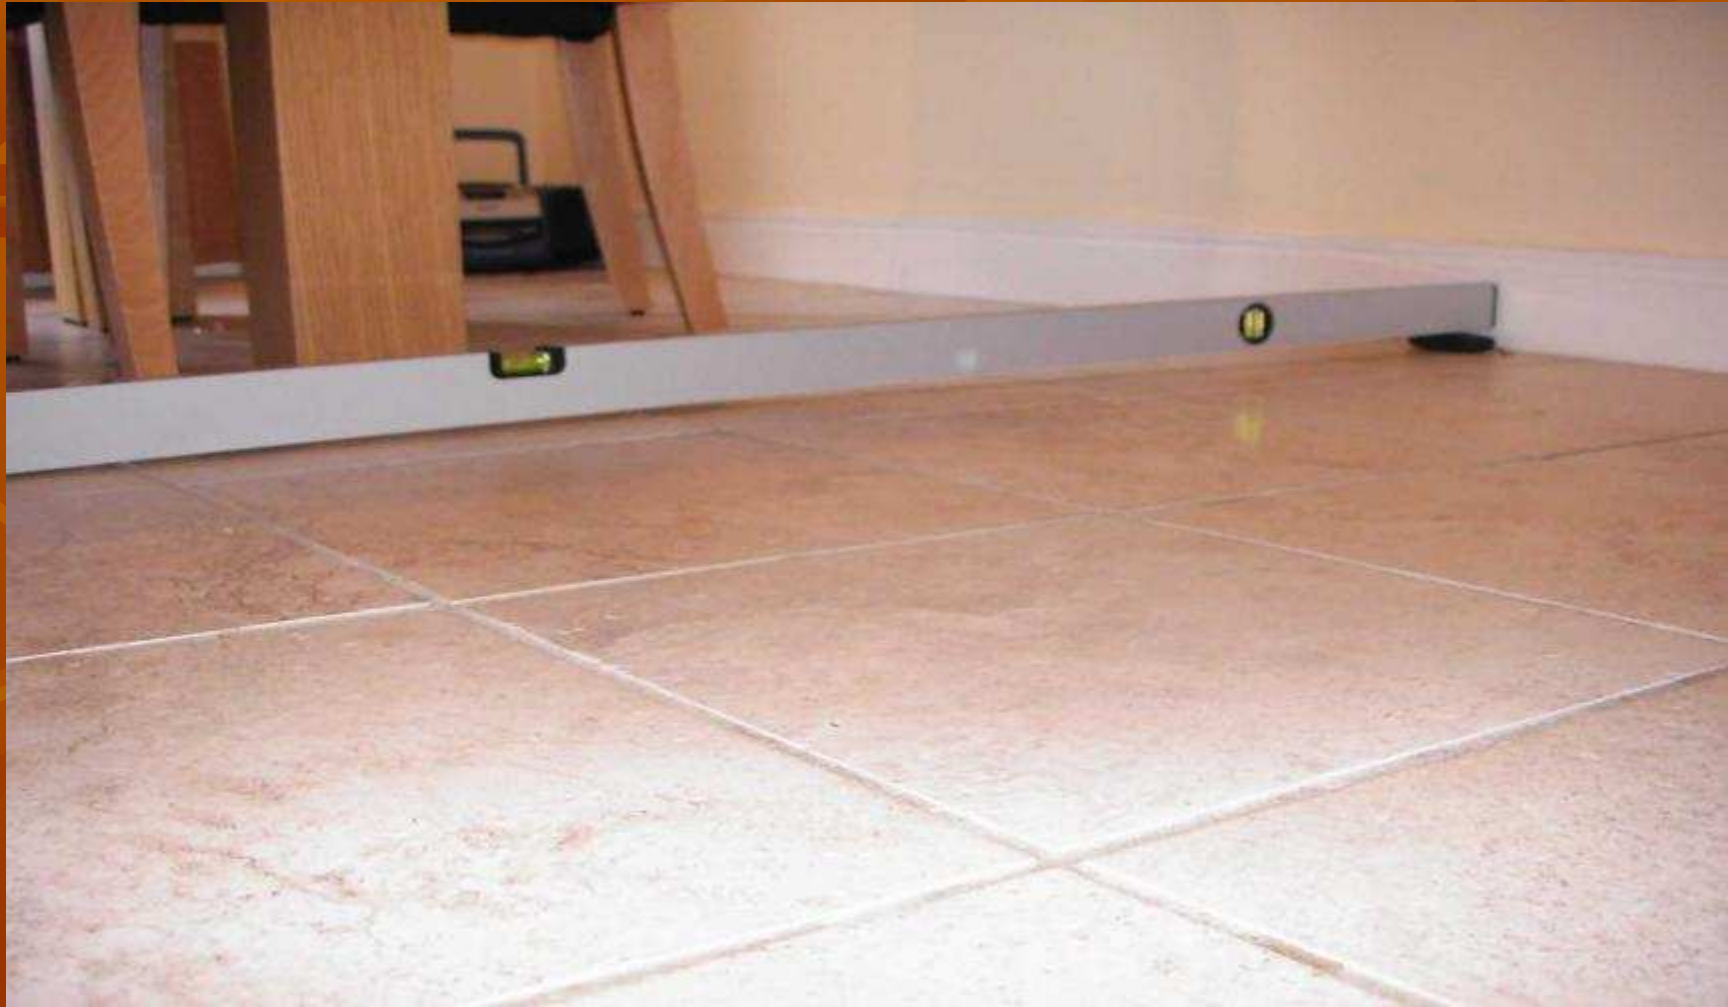
Bulging Floor caused by expanding pyrites

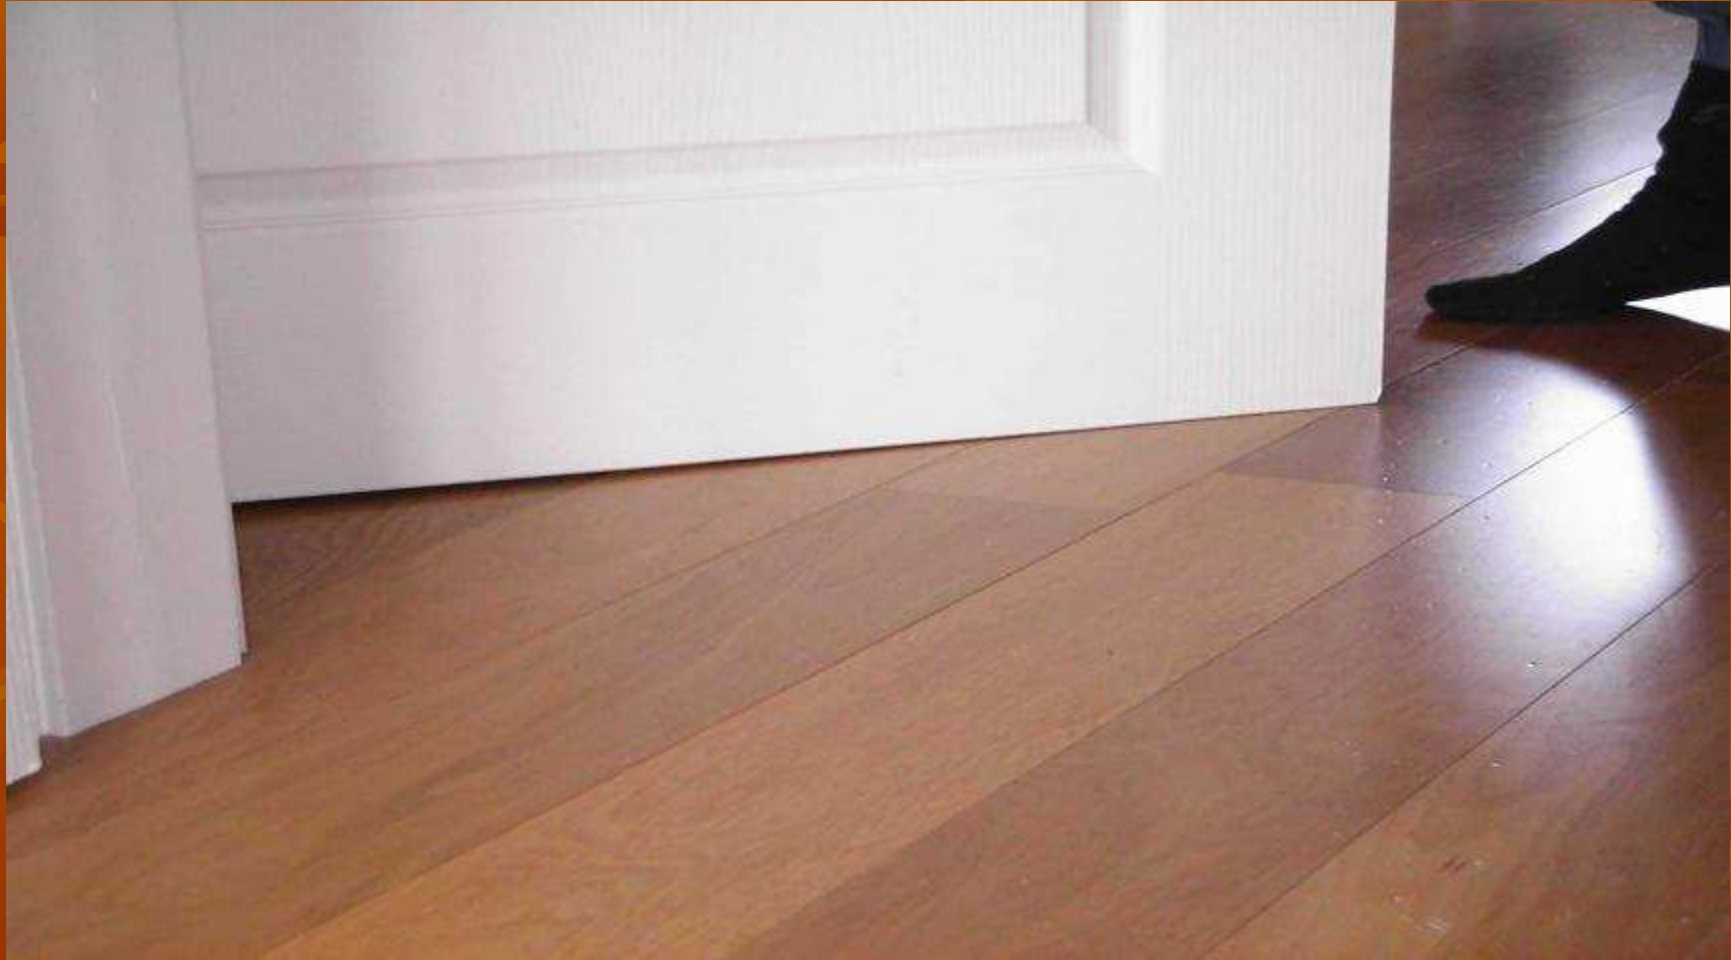
Internal door jamming

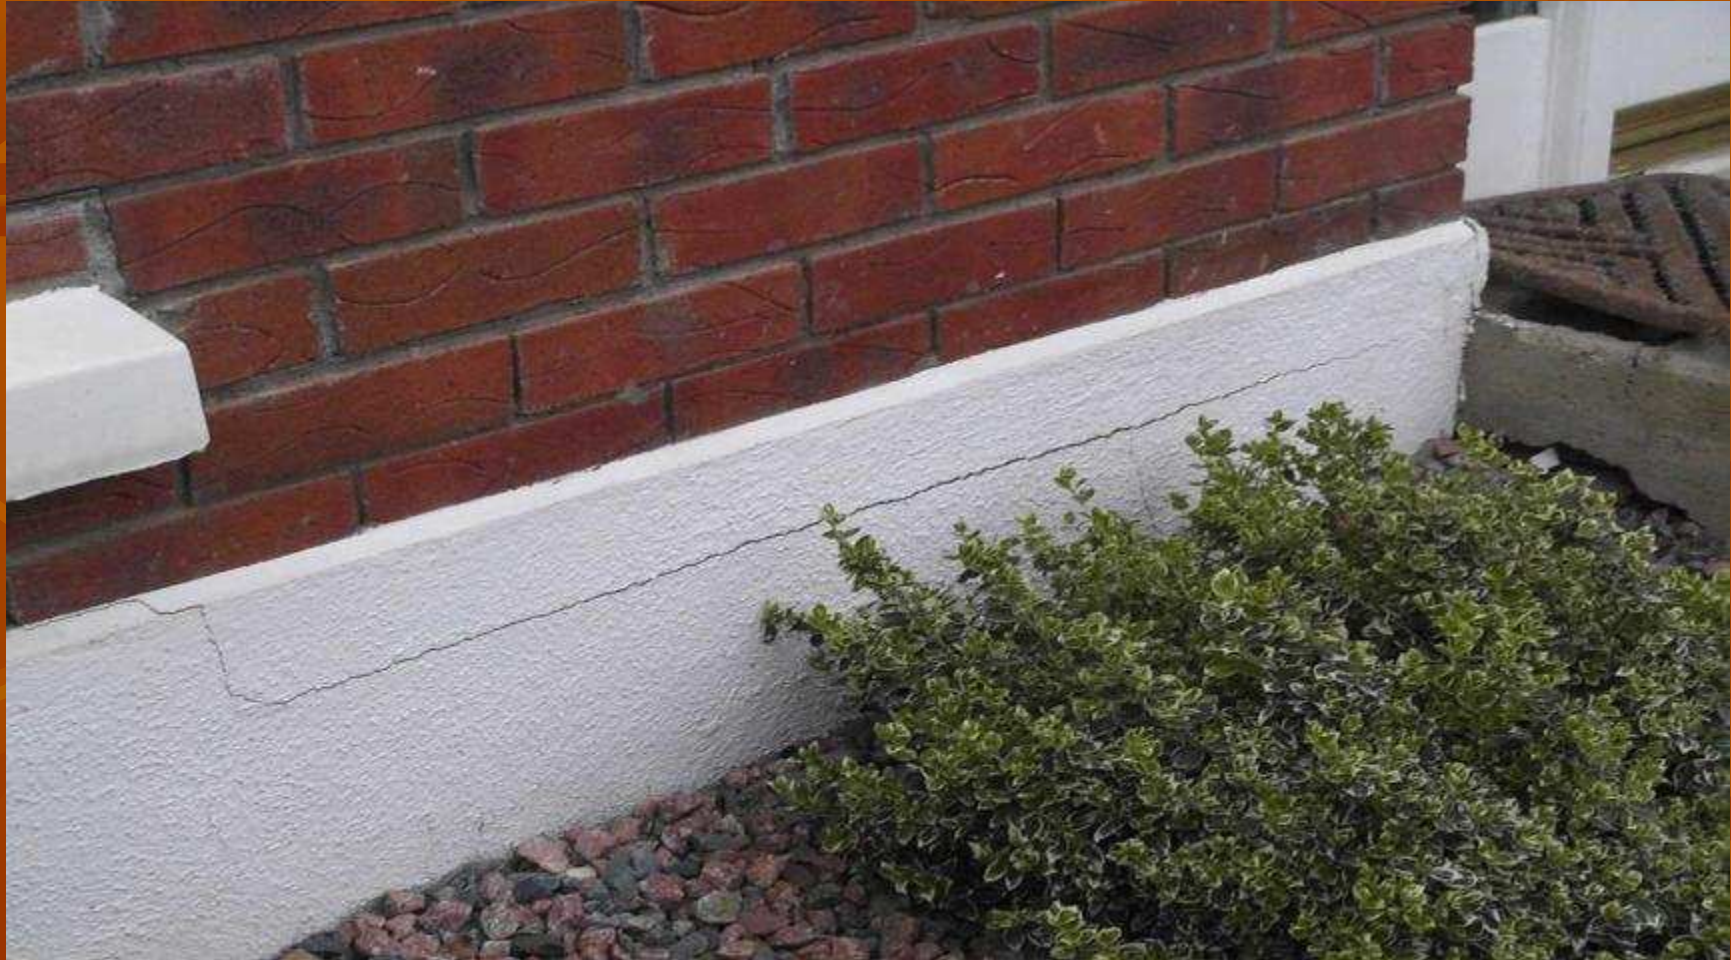
Structural Cracking

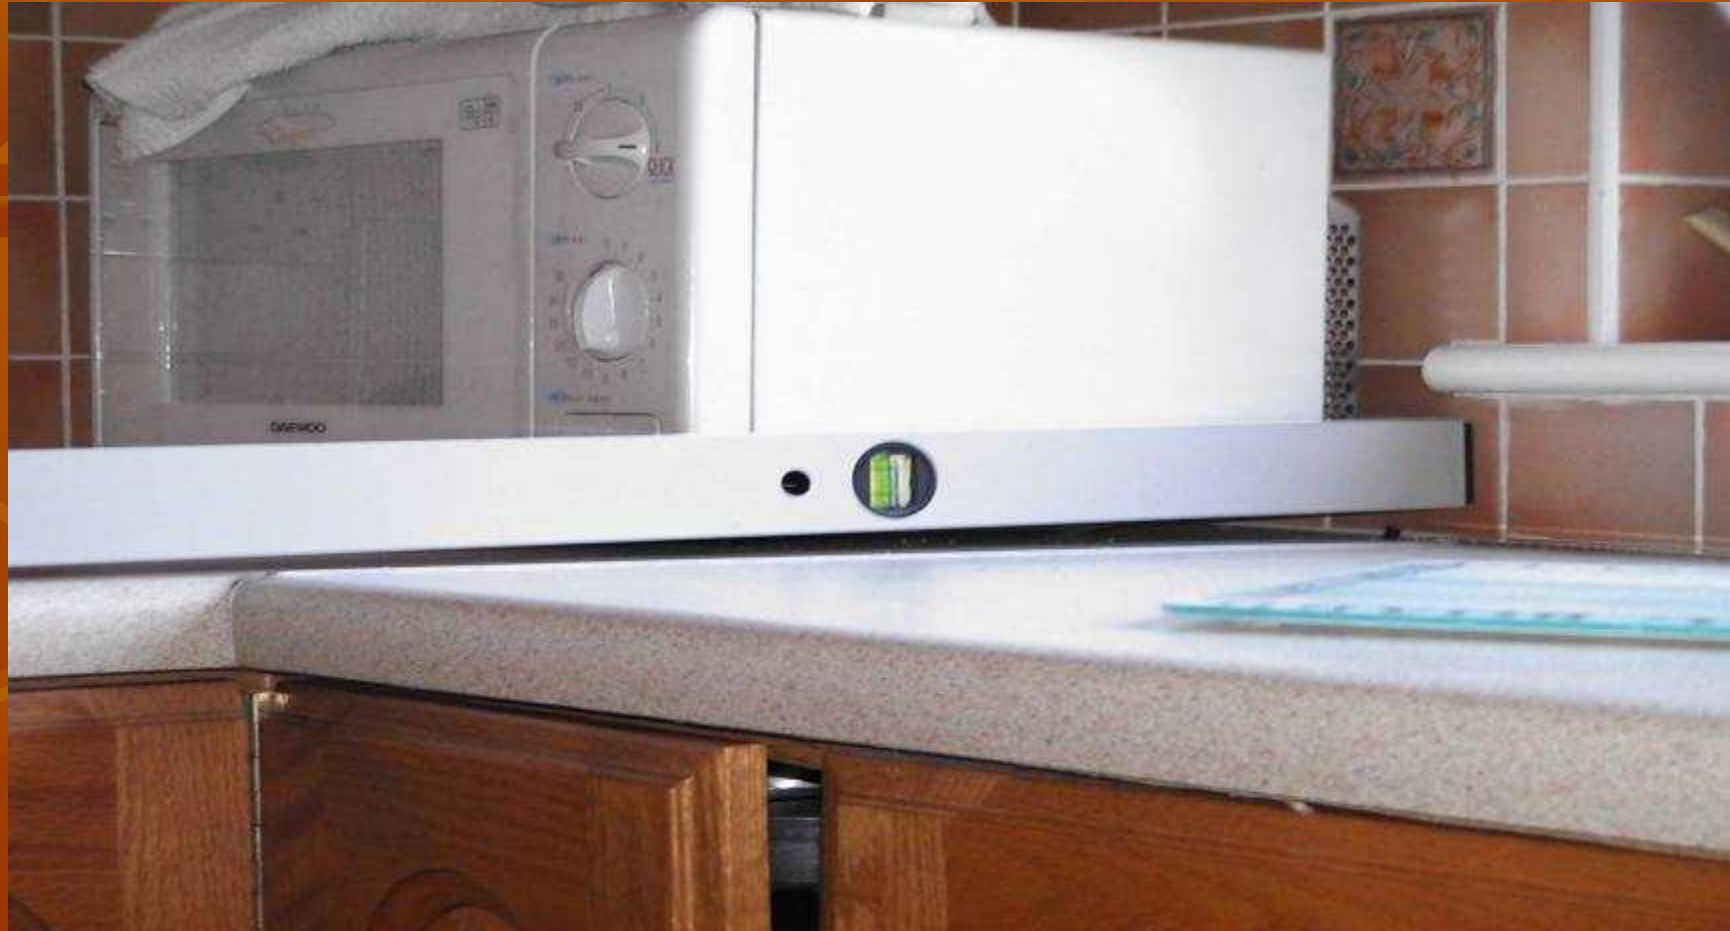
Kitchen Work Top Raised
